EVIDENCE OF NON-CONTIGUOUS FLOOD DRIVEN COARSE SEDIMENT TRANSFER AND IMPLICATIONS FOR SEDIMENT MANAGEMENT

G.L. HERITAGE⁽¹⁾, N.S. ENTWISTLE⁽¹⁾ & D.J. MILAN⁽²⁾

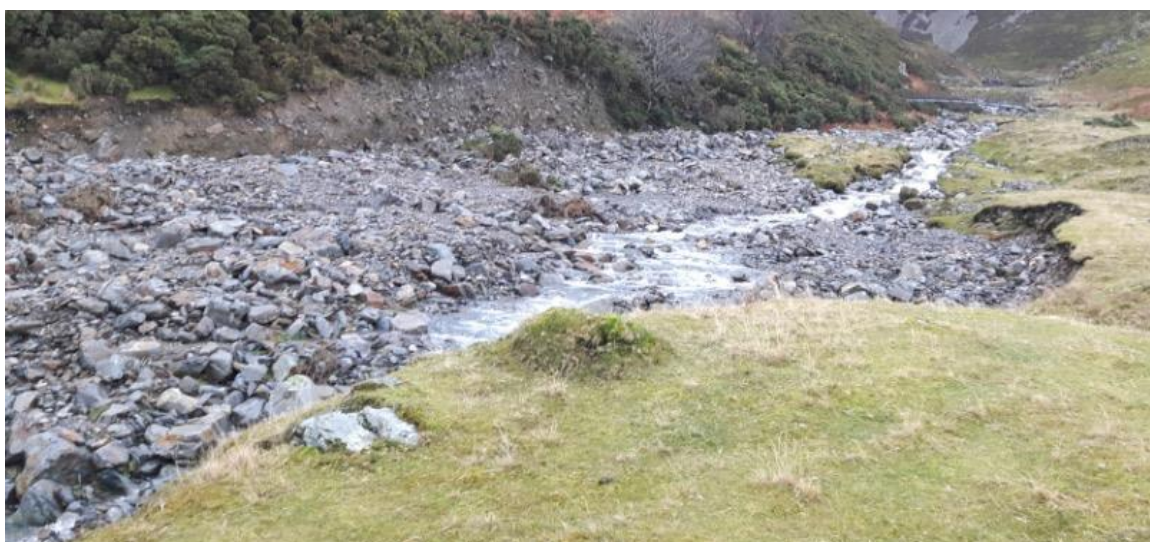
Figure 4. Evidence of overbank fine sediment stripping along Liza Beck.

Figure 2 illustrates the erosion and depositional pattern recorded across the Liza Beck torrent study site. Here change appears to have been more significant and concentrated at a morphologic unit scale, with significant local stripping of the floodplain surface revealing coarser palaeo-gravels beneath. Surface roughness data (0.05 m resolution) suggests sediment fining in the downstream direction (Figure 3), suggesting size selective transport with larger boulders deposited in the upstream reaches whilst finer material is deposited across overbank zones up to 500 m downstream. Such processes in the long-term probably explain the formation of the multiple fan deposits seen across the wider valley. The sediment budget (Table 2) suggests an almost neutral change along the study reach with erosive losses almost matching depositional gains downstream. The fluvial audit suggests that only finer sediment stripped from overbank areas was exported from the study reach (Figure 4).

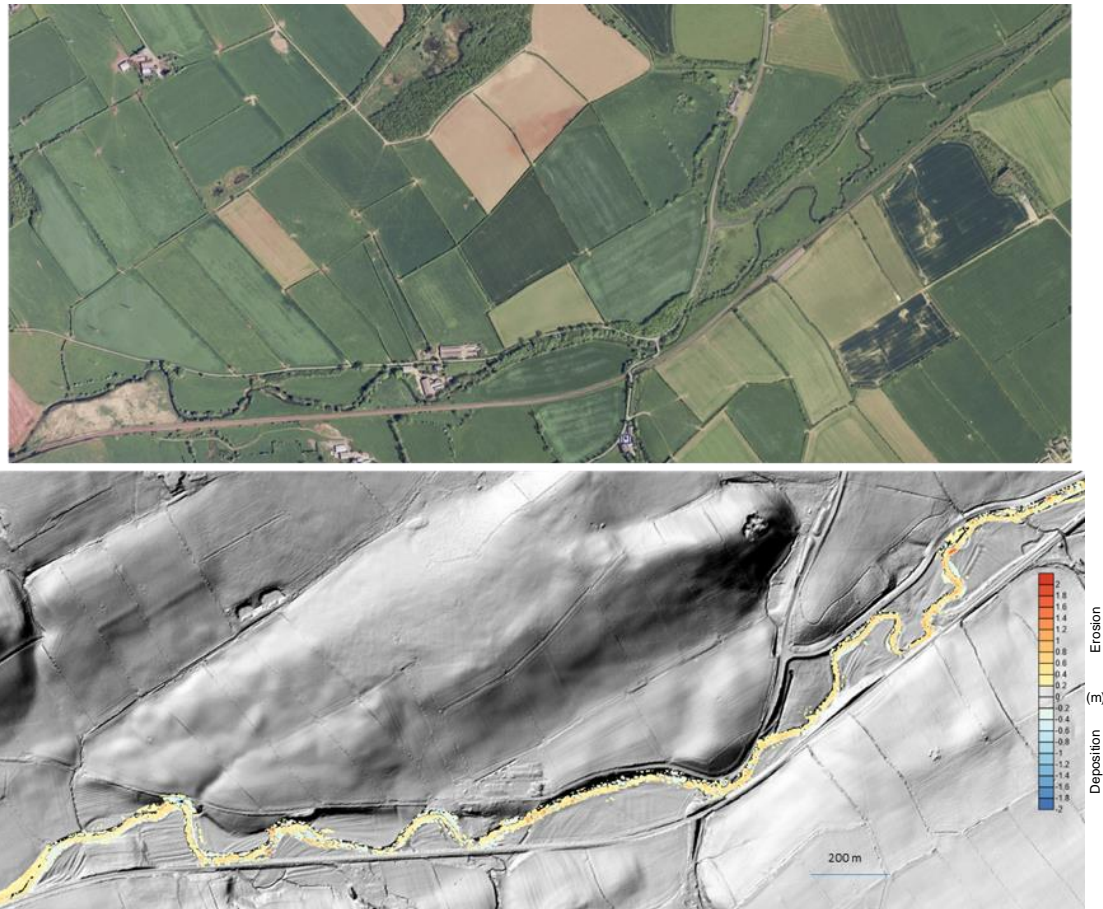
Figure 5. Orthophoto and DEM displaying measured morphologic change on the low gradient River Ellen active single thread study site. Flow direction is to the west.

Figure 5 and Table 2 suggest that the active sinuous single-thread reach of the River Ellen has accumulated sediment most notably in-channel with more patchy erosion and deposition across the floodplain. Evidence from the fluvial audit suggests localised bank erosion along outer bends and due to cattle poaching and deposition across the bed of the channel forming gravel riffle units and mixed sediment in-channel berms which have become vegetated. Accretion in the channel amounts to an average bed raising of 0.10 m which is likely to be significant from a flood risk perspective.

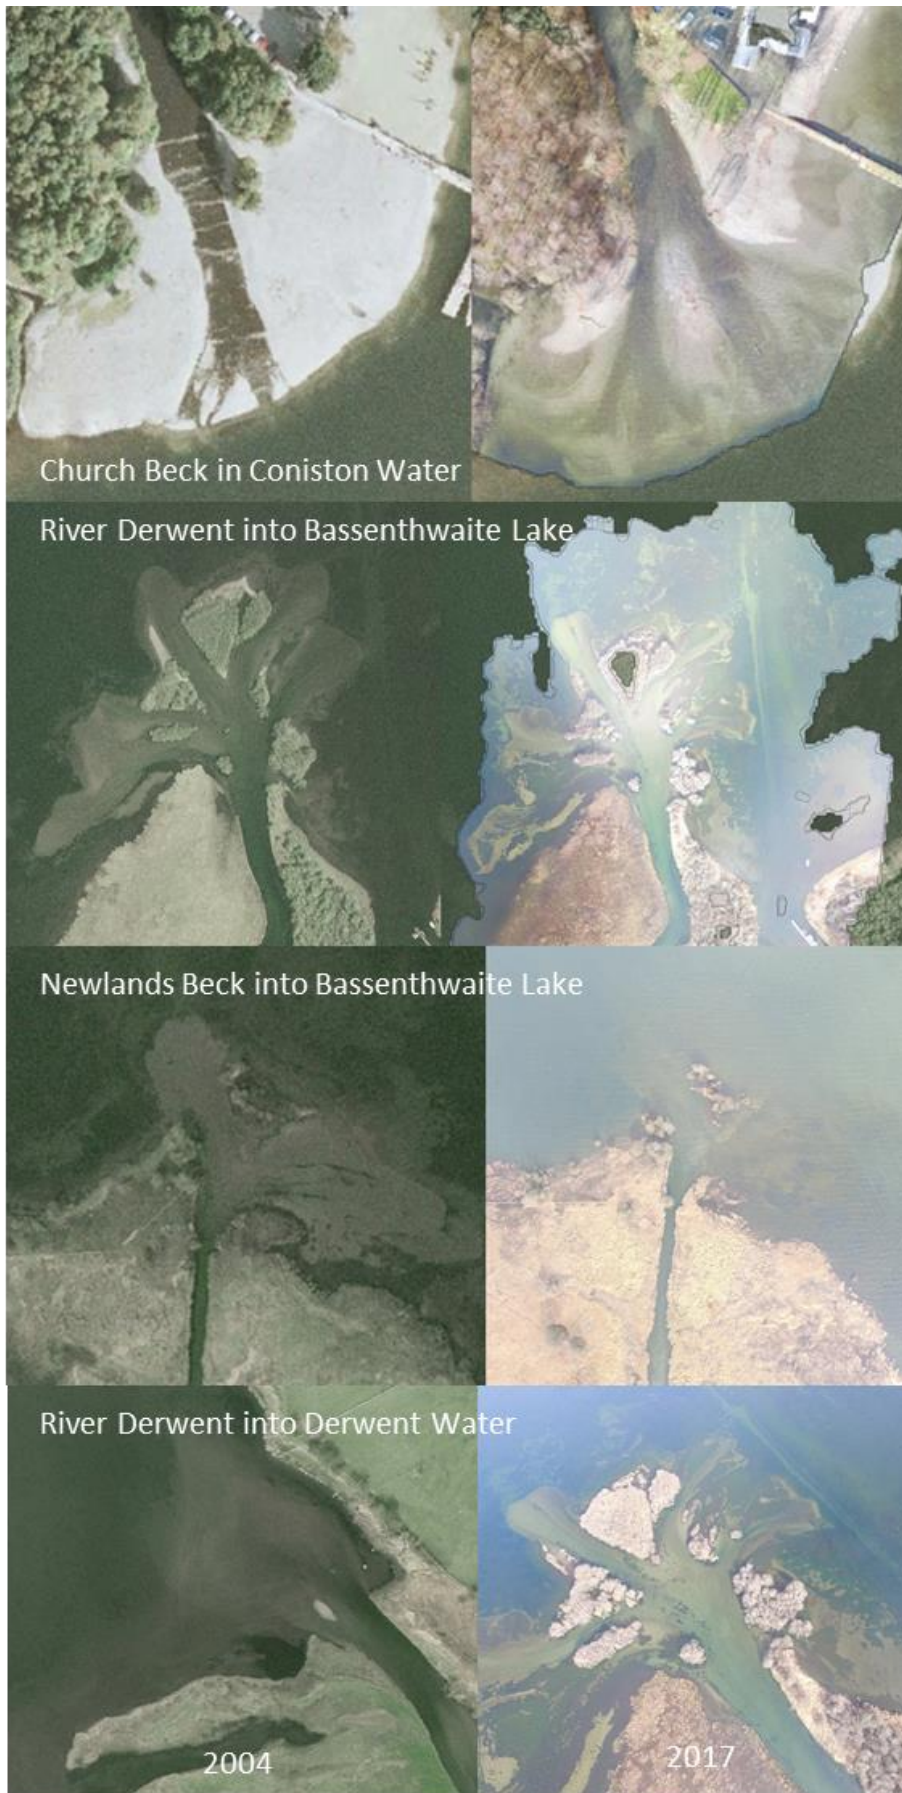
Figure 6. Lake fan change following Storm Desmond.

Overall sediment transport along Lakeland rivers was assessed visually, comparing Google Earth imagery of lake fan deposits on Church Beck entering Lake Coniston, the River Derwent entering Derwent Water and

Braithwaite Lake and Newlands Beck entering Braithwaite Lake (Figure 6). Despite differing water levels it is clear that there has been no significant growth of these features following Storm Desmond. This suggests that overall sediment movement along the watercourses assessed during Storm Desmond largely comprised redistribution of material within the channel-floodplain system, rather than sediment being evacuated out of the system.

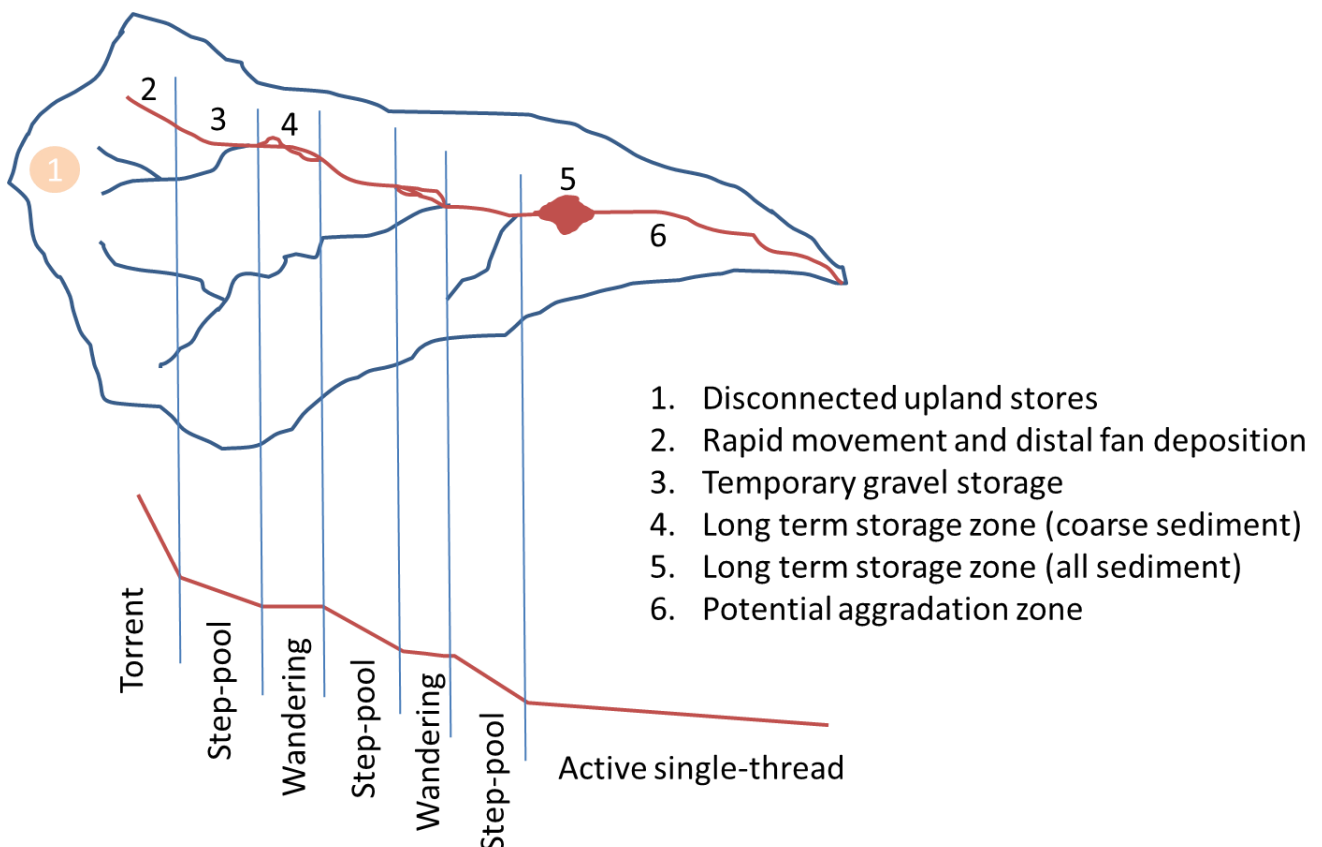
Figure 7. Summary bedload transport behaviour linked to channel type.

The results of this study are conceptualised in Figure 7 and show that channel change is a function of sediment source zone activity with extensive scree slopes and mine spoil not presently contributing to the active gravel transport regime of the rivers audited. Connectivity with the active channel network has also been shown to be critical. The short-term fate of transported sediment may be transient with deposition as flood waters recede followed by re-entrainment and transport during the next geomorphologically effective event or it may be more permanent with sediment being locked up across accumulation zones where the current flow regime is incompetent to cause further downstream movement. It would appear that even under quite extreme floods bedload transport distances are small with most sediment recorded as moving between adjacent morphologic units similar to the behaviour reported by Milan *et al.* (2002). It is suggested that the relic coarse-sediment in the upland channels studied develop a long-term armour (Parker and Klingeman, 1982; Gomez, 1983) that is periodically exposed and locally reworked before being buried under fine deposits.
